Geotechnical
Environmental and
Water Resources
Engineering

April 15, 2005
Project 050030

**Subject: Geotechnical Design Study
Simpson Road Bridge Rehabilitation
Saco, Maine**

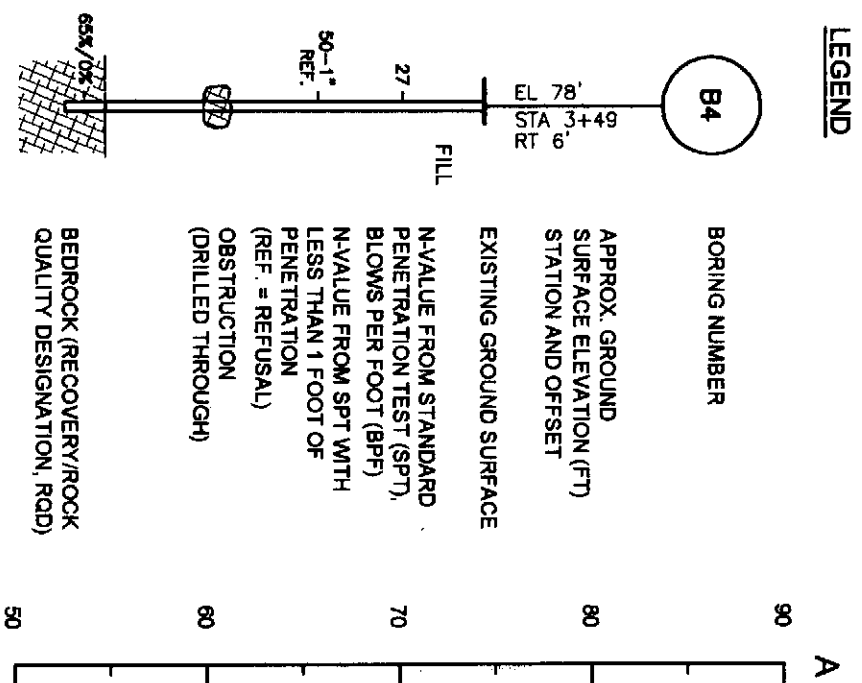
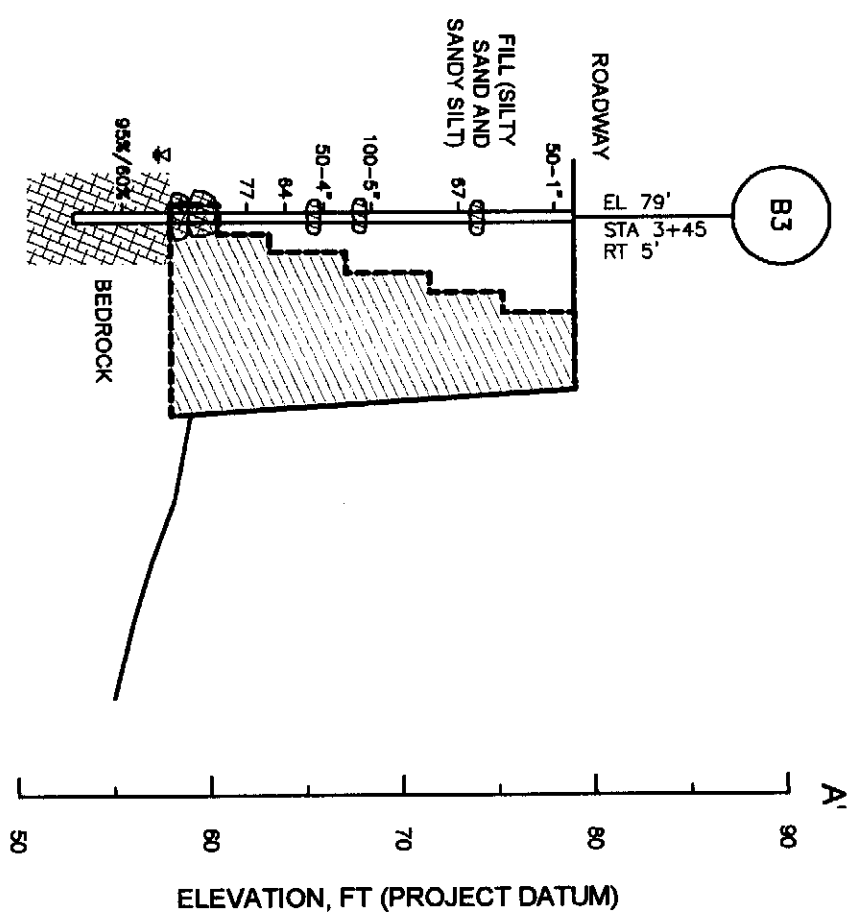
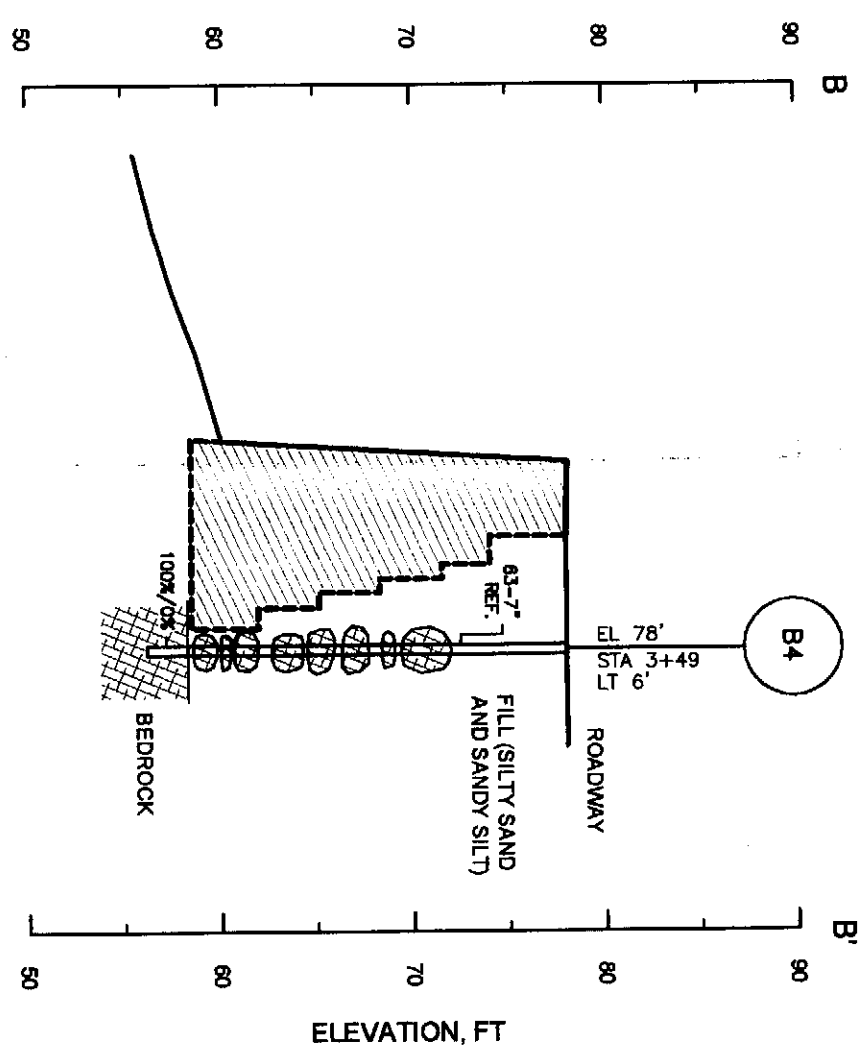
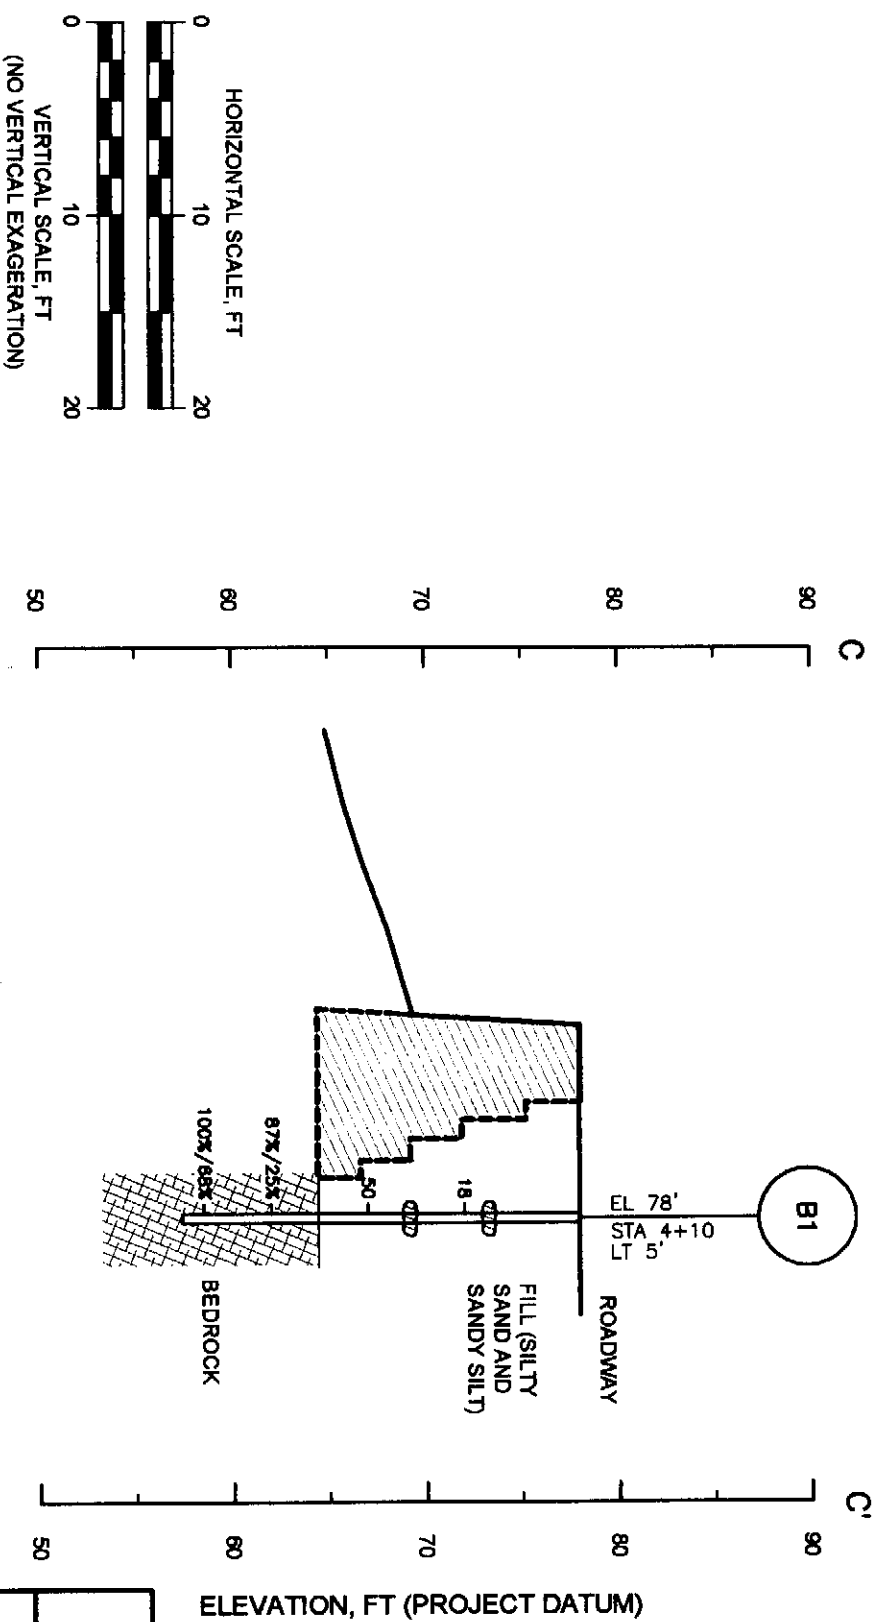
| Project 050030 | April 2005 | Fig. 3 | |

The subsurface conditions encountered in the borings are shown on the soil profile on Figure 3 and described below, from the ground surface down. Subsurface conditions are known only at the boring locations, and the conditions between borings may differ from those described in this report.

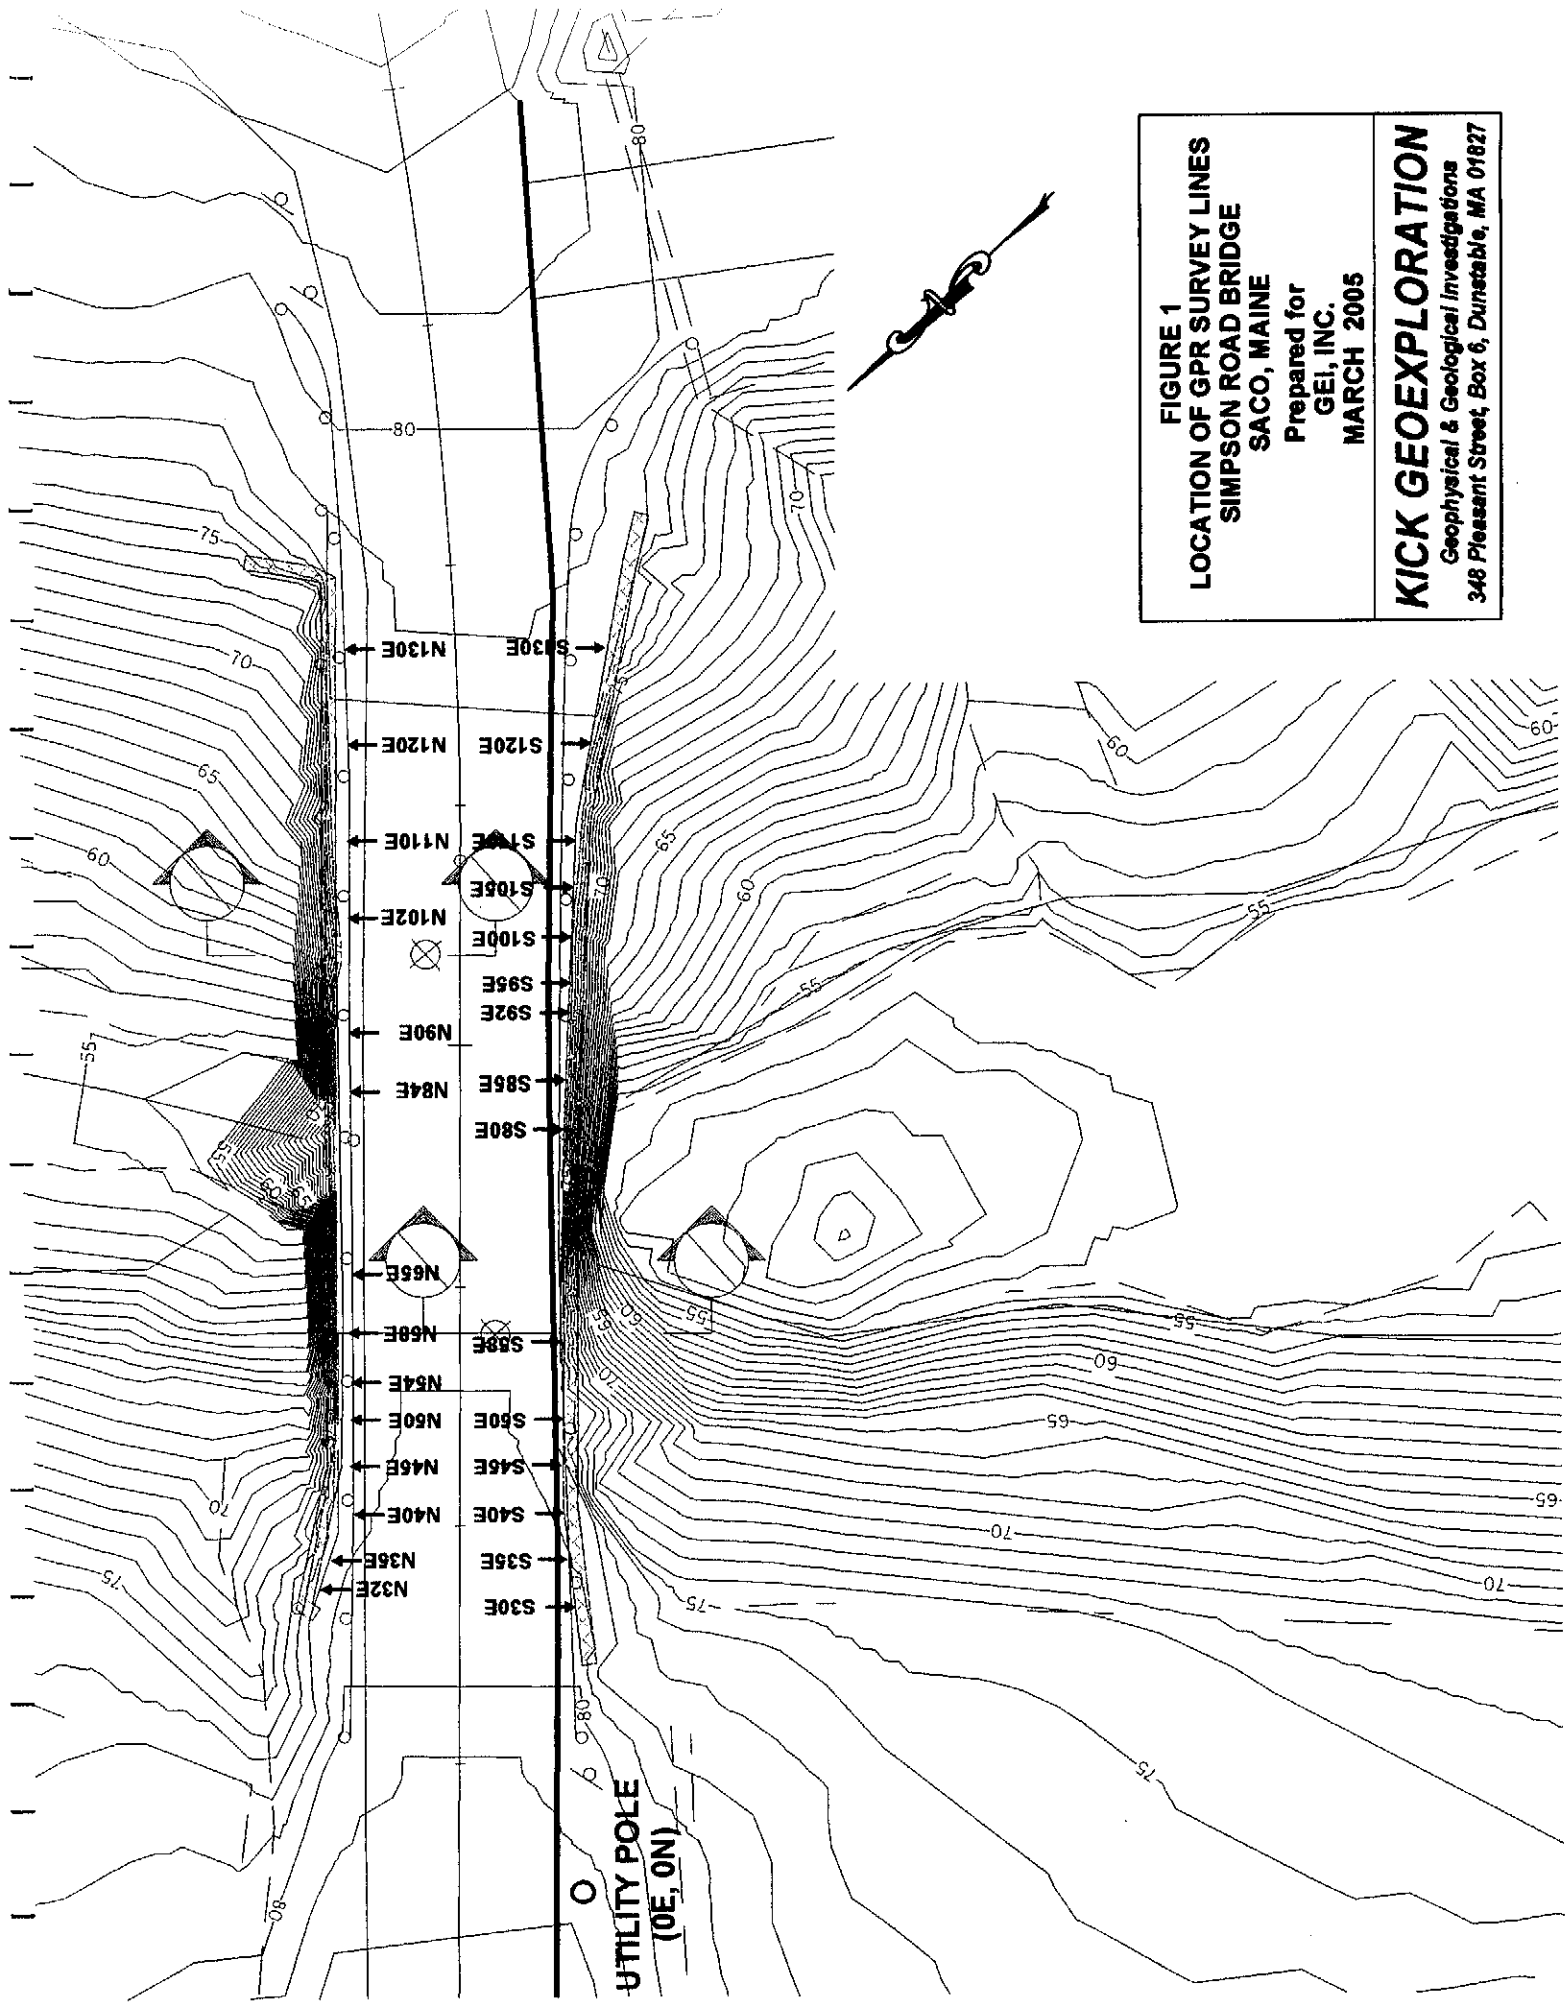
FIGURE 1
LOCATION OF GPR SURVEY LINES
SIMPSON ROAD BRIDGE
SACO, MAINE
Prepared for
GEI, INC.
MARCH 2005

GPR data were acquired along lines spaced approximately 5 feet apart and situated along both north and south walls. As Stackpole Creek bisects both walls, for purposes of this report, each portion of the wall surveyed was assigned a quadrant designation. Figure 1 shows the horizontal position of GPR survey lines, as referenced to a utility pole located southwest of the south wall, and to the top of the wall. Station 0 along each vertical transect corresponds to the top of the wall.

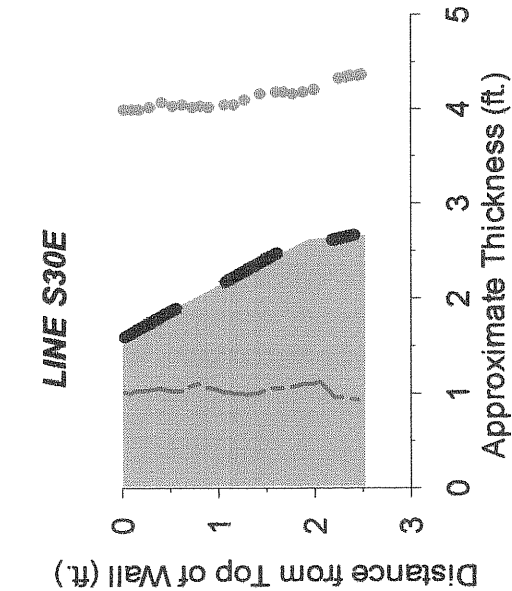
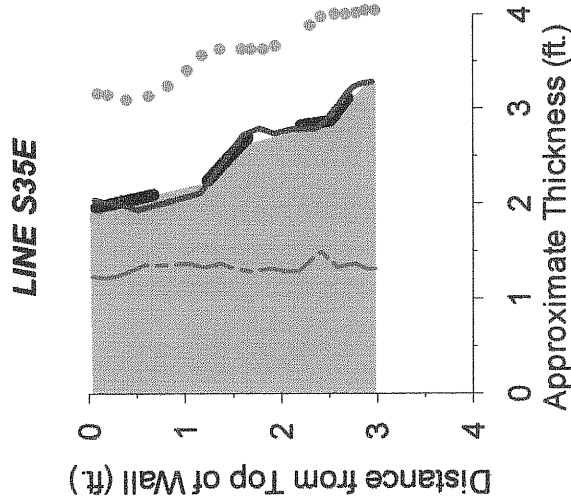
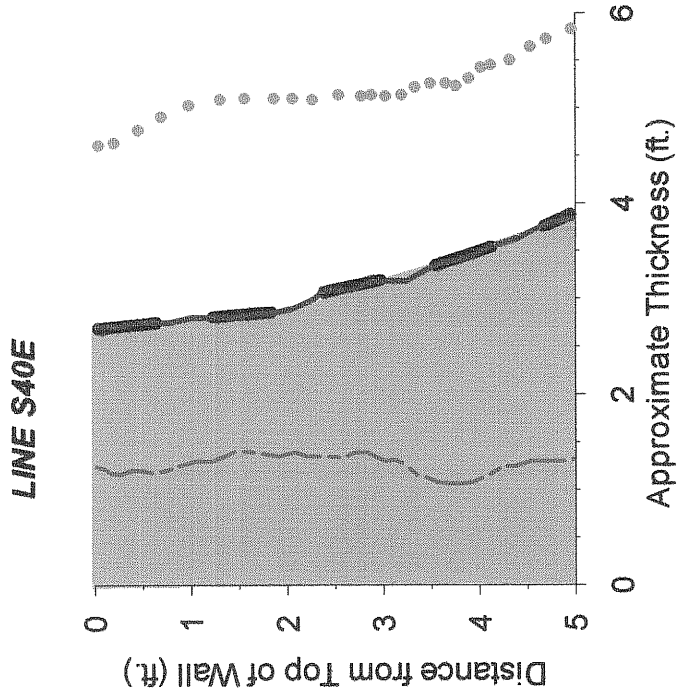
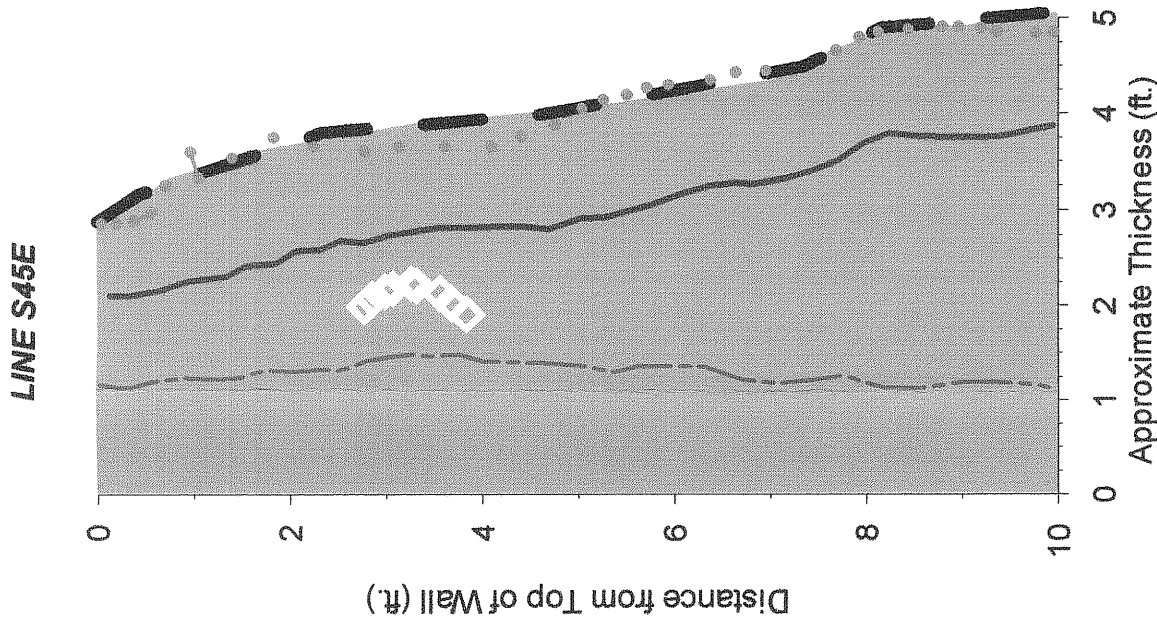
FIGURE 2
INTERPRETED GPR RESULTS
SOUTHWEST QUADRANT (Q1)
SIMPSON ROAD BRIDGE
SACO, MAINE
Prepared for
GEI CONSULTANTS
APRIL 2005

Southwest Quadrant (Figures 2 -3)

The interpreted thickness of the bridge wall increases eastward at the top and bottom, towards the bridge center. The minimum of thickness of the wall at the base of lines S50E and S58E on figure 3 is about 8 feet. The wall, at its thinnest point (i.e along Line S30E) is about 3 feet in thickness.
